Parkview Elementary School

School District No. 83 (North Okanagan-Shuswap)

Odour Assessment Report

4 October 2019

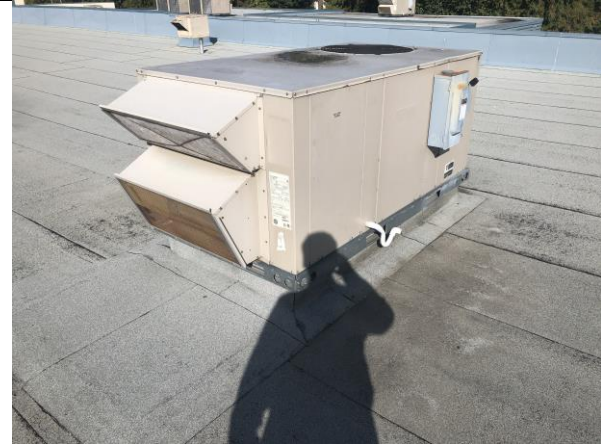
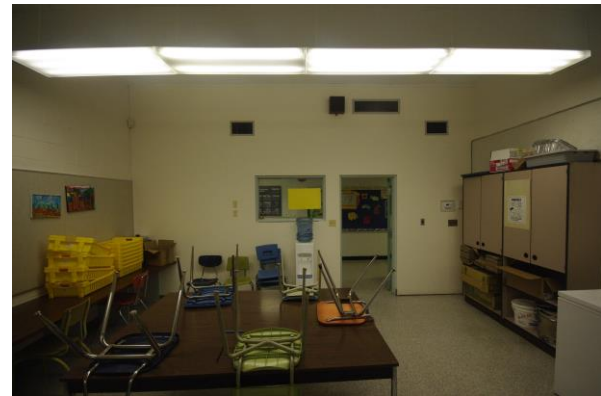
Roof Top Units

<p>Observations:</p> <ul style="list-style-type: none">◆ The terminal equipment for the bulk of the occupied zones is served by all electric roof top units.◆ The outside air intakes (top louvre) are well away from common odour sources.◆ It is noted that the units are not propane fired, thereby eliminating that potential odour source.◆ The duct systems are well configured with ducted supply and ducted return air, except for the gym where the return air is awkwardly routed through the crawlspace.◆ The ceiling spaces and crawlspaces are not used as a return air path except the gym.◆ A few spot checks on the duct system showed that they were as clean as many other facilities.

<p>Recommendations:</p> <ul style="list-style-type: none">◆ Reconfigure the gym return air path and provide dedicated exhaust system for the gym crawlspace.

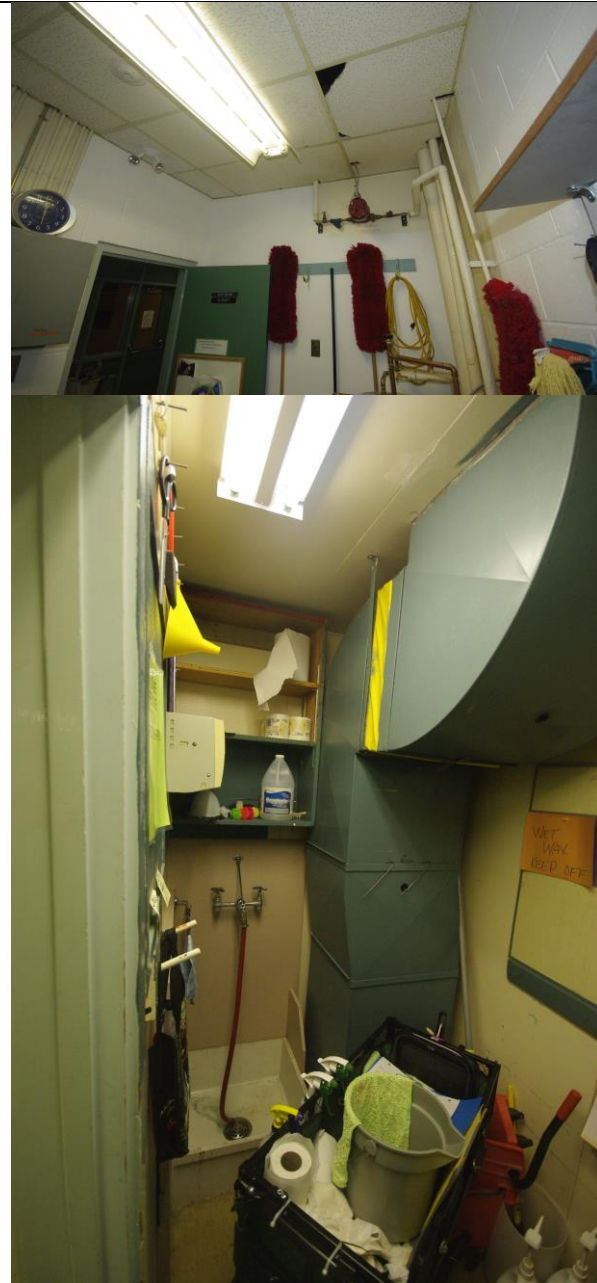
Main Floor Exhaust System

- ◆ All the spaces that require exhaust have systems connected to them, except for two.
- ◆ The custodial rooms on the east end and west end of the building do not appear to have any exhaust systems.

- ◆ An exhaust system should be added to the east and west custodial rooms.
- ◆ If something very odorous was stored in this space, it could have contributed to the odour event, as there is no exhaust in these custodial rooms. Whatever the potential source could have been, was removed by the time of inspection.
- ◆ The exhaust systems air balance should be checked to ensure adequate exhaust air flow for each zone.

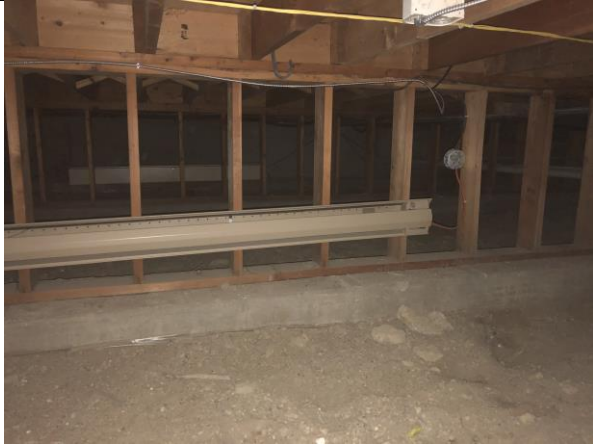
Crawlspace Exhaust Systems

Observations: <ul style="list-style-type: none">◆ At the time of inspection, the crawlspaces were dry. There was surprisingly little odour in the crawlspace compared to other facilities. This is likely due to the recent odour mitigation efforts.◆ The crawlspace on the west end of the building has an exhaust system.◆ The crawlspace under the gym area is ventilated in a very unconventional manner and could encourage odours in the crawlspace to enter the occupied area.◆ The crawlspace under the central portions of the building has been provided with electric heaters but does not have an exhaust system.
	Recommendations: <ul style="list-style-type: none">◆ If for some reason, the crawlspace gets wet, it may generate the musty type of odours reported during the odour event. However, the intensity of the odour described is probably not attributable to the crawlspace. There is likely another odour source to account for the intensity, that has been removed since.◆ Nonetheless, it would be advisable to have an exhaust system serving each crawlspace, to keep that space under negative pressure in relation to the occupied space, during occupied hours.

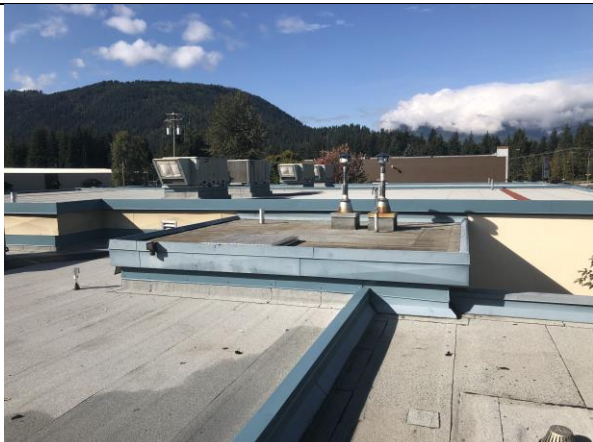
Propane Systems

Observations: <ul style="list-style-type: none">◆ At the time of inspection, no mercaptan (the odorant added to propane) was detectable.◆ The boiler venting systems are installed to code.
	Recommendations: <ul style="list-style-type: none">◆ No upgrades are anticipated as part of this review.

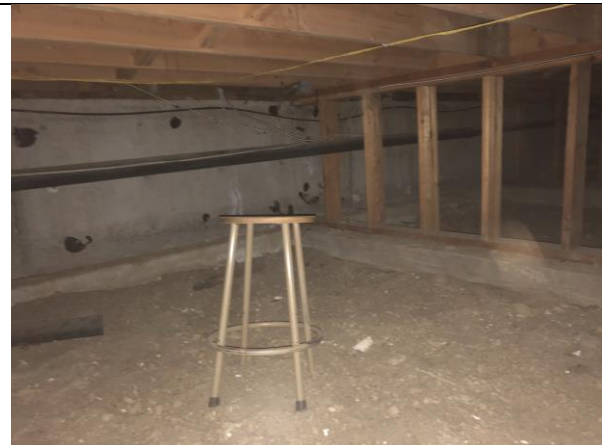
Sanitary and Storm Drainage Systems

Observations: <ul style="list-style-type: none">◆ At the time of inspection, there was no indication of sanitary or storm systems backing up or overflowing within the building.
	Recommendations: <ul style="list-style-type: none">◆ No upgrades are anticipated as part of this review.
